Fire Risk and Safety Measures in General Electrical Equipment

In this article, we introduce fire prevention measures for fires caused by general electrical equipment, based on examples of fire accidents.

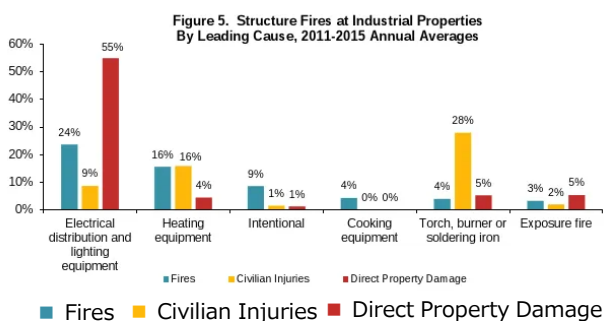
The figure below shows the sources of fires in industrial properties from 2011 to 2015, according to National Fire Protection Association (NFPA) report in 2019. The largest number of fires originated from electrical distribution and lighting, indicating that electrical equipment is a very high fire risk.

Sources of Fires in Industrial Facilities (U.S.)

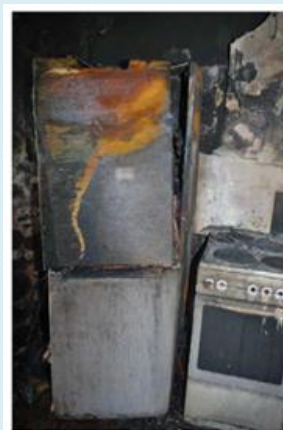
Refrigerator that started the fire^[2]

Fire broke out from a refrigerator (London, 2017)

At 1:20 AM, a fire broke out from a refrigerator on the 4th floor of a high-rise condominium. The fire spread to exterior materials and spread throughout the entire condominium.

- Cause of fire: The actual cause is unknown, but the fire was believed to have started from an electrical failure in the refrigerator [2] (Ignition of cables, malfunction of the refrigerator itself, etc.).
- Factors contributed to the spread of damage: The fire spread throughout the entire condominium because the exterior materials were combustibles. Victims testified that they could not find their way out[2]. It was possible that the poor visibility during the late night caused victims to delay their escape, leading to the spread of the damage.

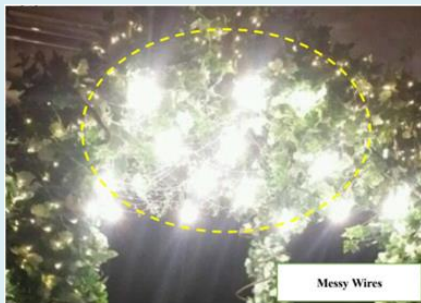
Wedding store ceiling lighting and ambient conditions[3]

A fire broke out from a lighting circuit above the atelier of a wedding store, spreading to decorative artificial flowers and polyurethane interior materials, destroying the building and killing 15 people.

- Cause of fire: The electrical wiring was disorganized and had deteriorated, and the fire started due to poor cable contact.[3] There may have been a lack of awareness that lighting and wiring cables were one of the ignition source.
- Factors contributed to the spread of damage: The ceiling of the wedding store was covered with artificial flowers, which caused the building to burn down through combustible materials.

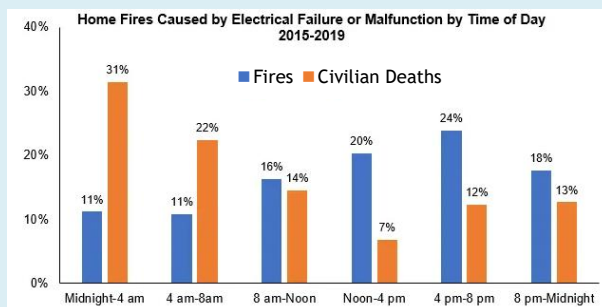
Number of electrical fires in homes and time of day[4]
Source: [NFPA report - Home Electrical Fires](#)

C. Production equipment often operate during operating hours, whereas general electrical equipment are often in operation 24 hours a day. Damage can easily spread if evacuation is delayed due to sleeping, or initial firefighting is not possible in the late-night hours when no one is around to extinguish the fire. (Case 2, Reference figure: Number of electrical fires in homes and time of day)
